# Manhole Inspection Summary

Manhole # S05GG2006MH

Insp Date: **7/24/06 8:41 AM**

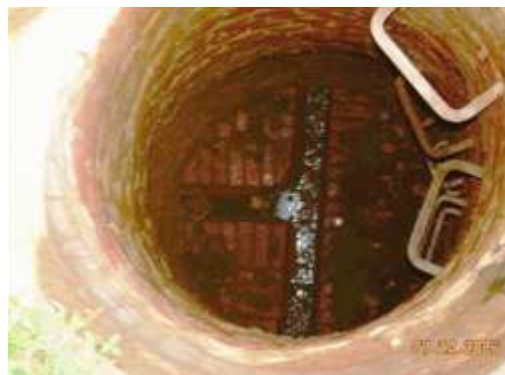
Top View

Frame leaks. Adjustment and Corbel infiltration. Evidence of surcharge - Bench debris. Corroded steps. Channel debris.

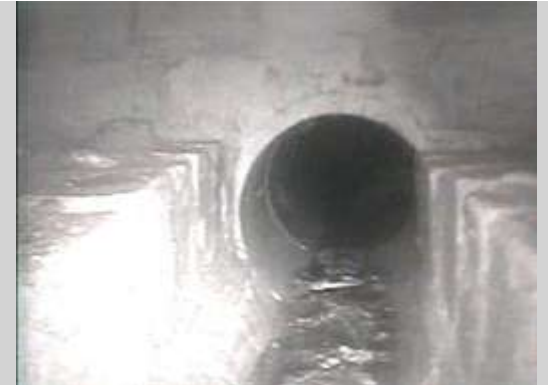
### 8 in. Circular Gravity Sewer Pipe Out @ 12 O'Clock

Infiltration: **None** Pipe Seal Cond: **Unknown**

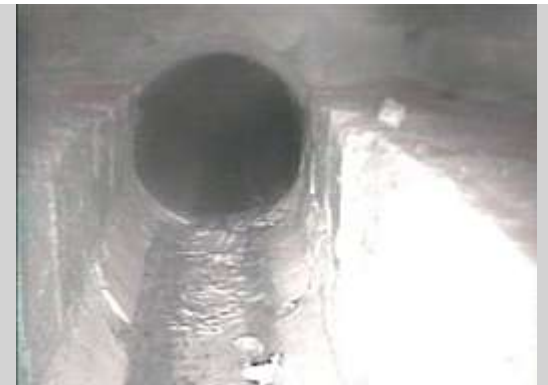
### 8 in. Circular Gravity Sewer Pipe In @ 6 O'Clock

Infiltration: **Evidence** Pipe Seal Cond: **Unknown**

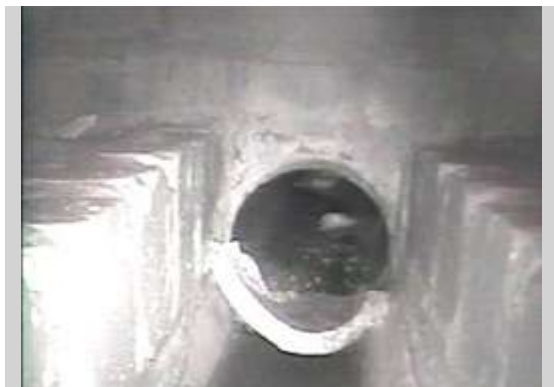
6 in. Circular Gravity Sewer

Infiltration: **Evidence**

Pipe Seal Cond: **Cracked**
